Long-term Impressions Moto Guzzi Le Mans Mk II

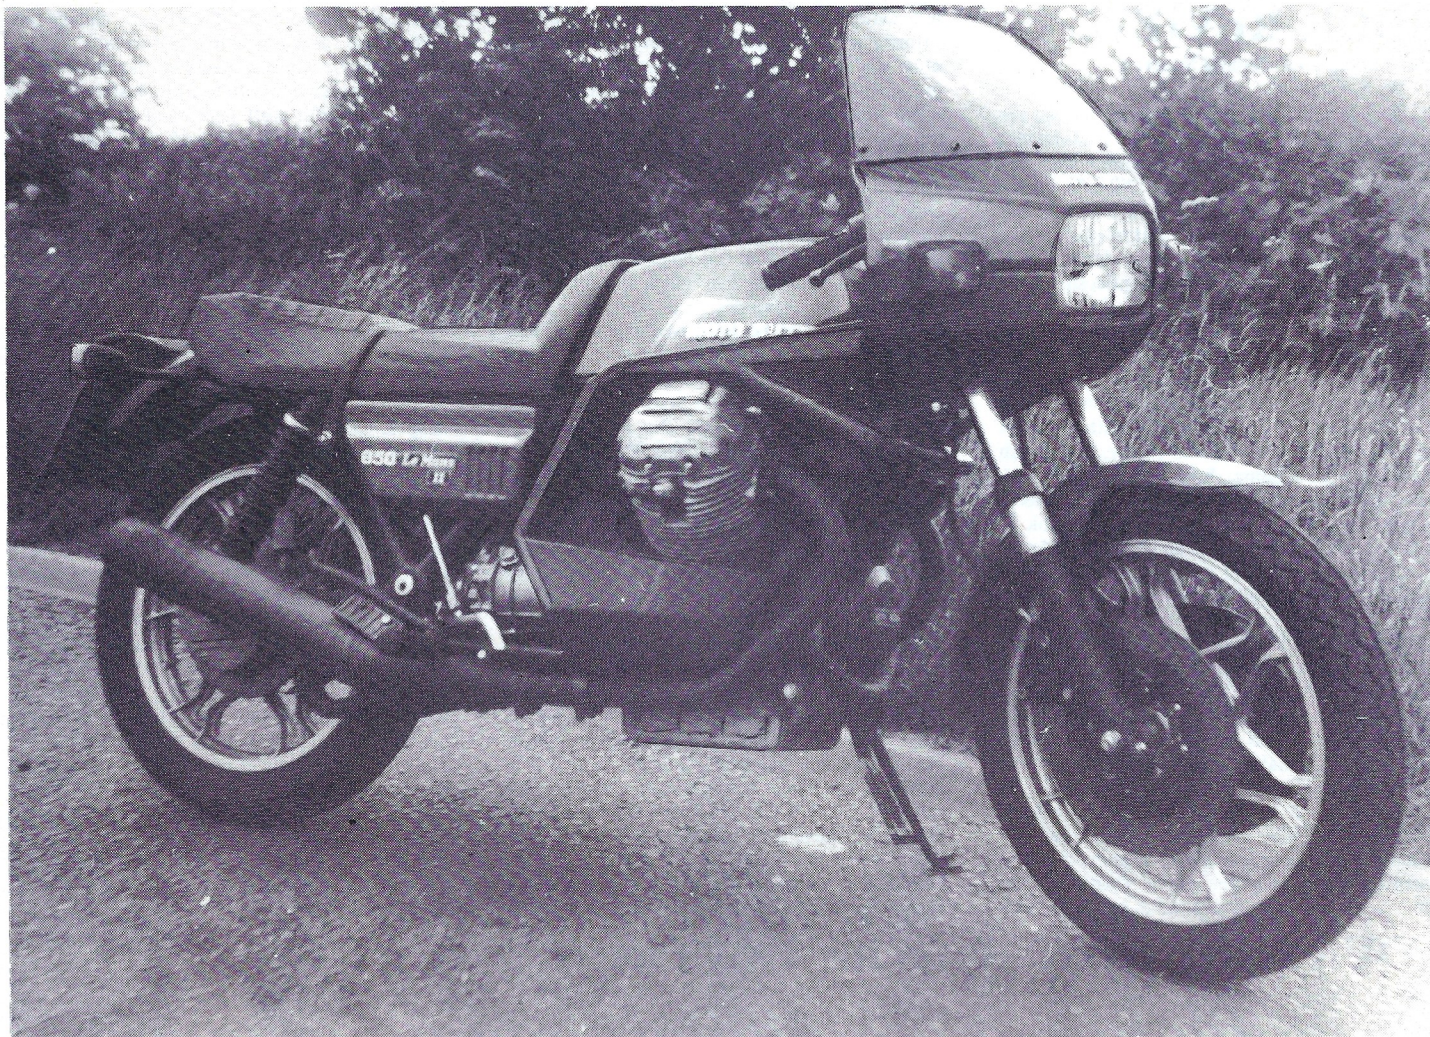
"I decided I had to have a Mk. II . . ."
